Problem

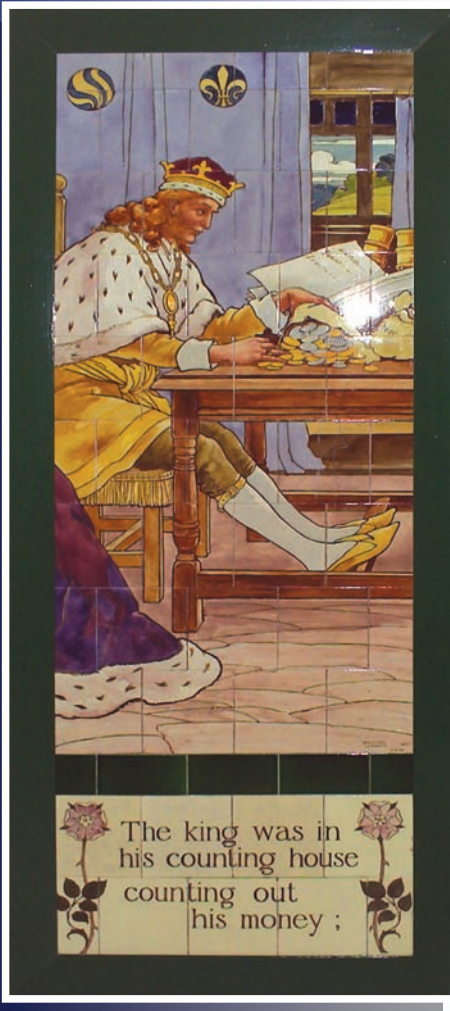
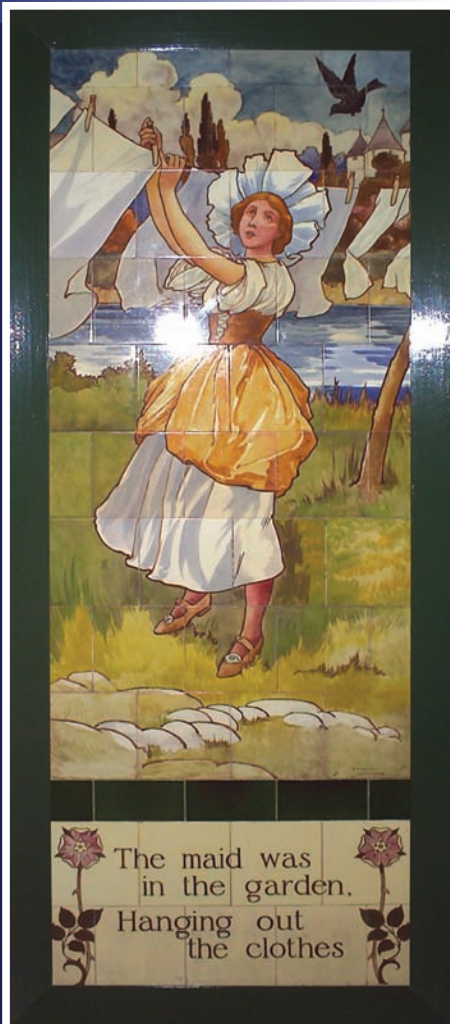
CHASE FULL DEPTH OF PLASTER

DIAMOND WIRE

SWIVEL TROLLEY WHEEL PULLEYS

DRILL FRAME TO TRAVEL MOTOR AND TENSION WIRE

FIXINGS

BESPOKE RUBBER DRIVE PULLEY WHEEL

110v ELECTRIC DRIVE MOTOR AND TRACK FIXED TO WALL

The process was started by gluing a board and holding a frame on the face of the tiles, and then cutting down behind the panels so that there was nothing left but the original tile cement. That meant they could then be moved safely.

D-Drill experts cut a chase around the perimeter through the plaster and render in which the panels were supported using a 110-volt diamond hand held saw.

The diamond wire was fed into the chase and on to a wire saw drive machine which was powered by a 110-volt electric Shibuya 2521 drive motor fitted with a bespoke rubber drive pulley wheel, then onto the guide pulley wheel system.

The equipment was built and put together in D-Drill's own workshop and gave precise control over the diamond wire as it cut down behind the panels without cutting the tiles.
